KOBEBE DAM THIRSTY FOR INTERVENTION AS WATER RUNS DRY

Kobebe Dam in Moroto district is experiencing a significant decline in water levels, raising concerns of an impending crisis. This situation poses a serious threat to pastoral communities that rely on the dam for watering extensive herds of animals

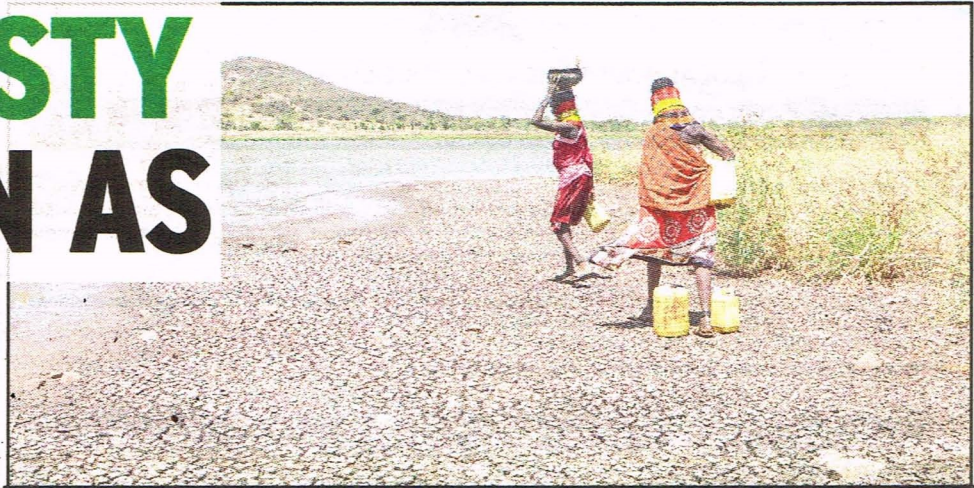
A *New Vision* visit to Kobebe Dam revealed dramatically receding waters, with wide stretches of the reservoir bed now exposed.

Black cotton soils in the basin have cracked into dry, cake-like formations under intense heat, while millions of fish struggle for survival in shallow, algae-choked pools.

He appealed to the Ministry of Water and Environment to urgently repair the dam and restore its catchment area ahead of the next rainy season expected in March.
